Manhole Inspection Summary

Manhole # S55E__046MH

Insp Date: **7/21/08 10:34 AM**

Location Address: **3405 leverton ave**

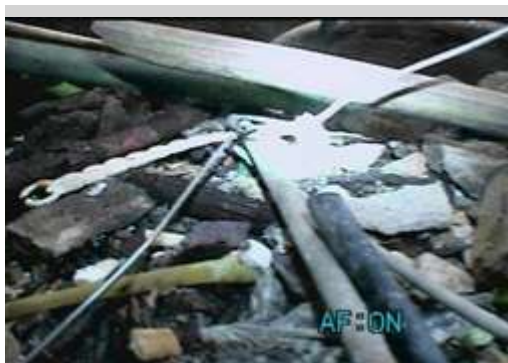
Defect 4

Condition: ☐ Sound ☐ Cracked ☐ Root Intrusion ☐ Deteriorated ☐ Leaks ☒ **Debris**

bench and channel debris

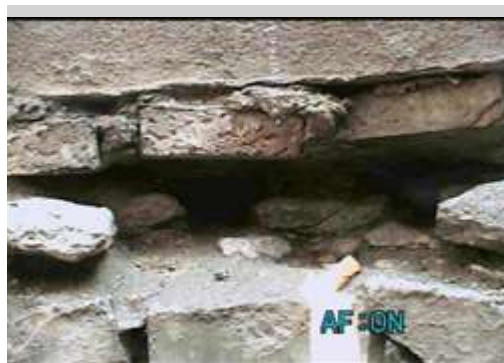
Defect 3

Condition: ☐ Sound ☒ **Cracked** ☐ Leaks

Condition: ☐ Sound ☐ Cracked ☐ Root Intrusion ☒ **Loose Brick** ☒ **Deteriorated**

chimney loose bricks, deteriorated,
frame adj

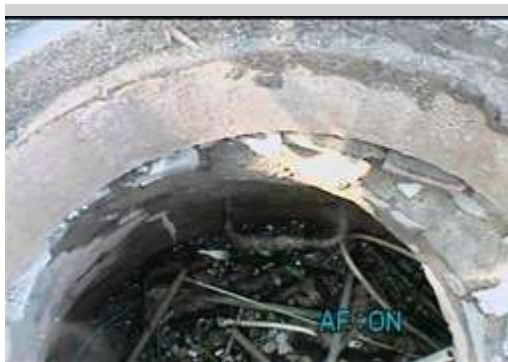
Defect 2

Count: **1** Missing: **0** ☒ **Corroded**

step

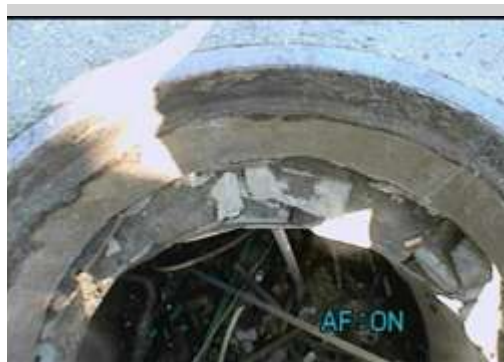
Defect 1

Offset: **2.5** (in.)

offset
